Massachusetts Department of Environmental Protection
Bureau of Resource Protection – Watershed Permitting Program
Sanitary Sewer Overflow (SSO)/Bypass
Notification Form

Hull, MA WPCF

Unauthorized Discharge Summary Hull WPCF [08-08-18]

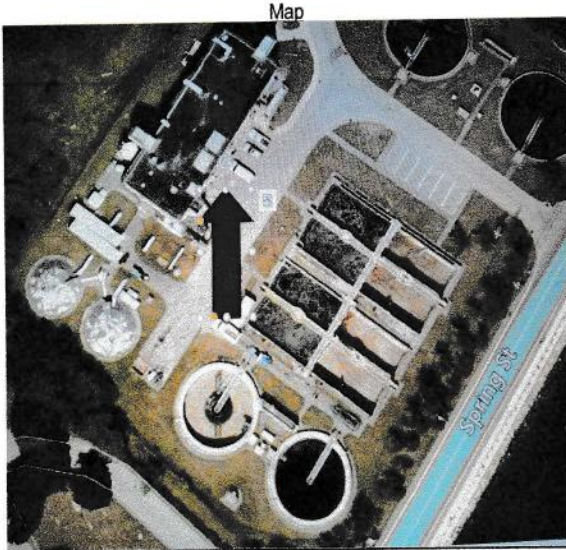
ARROW SHOWS AREA WHERE TRUCK PARKED

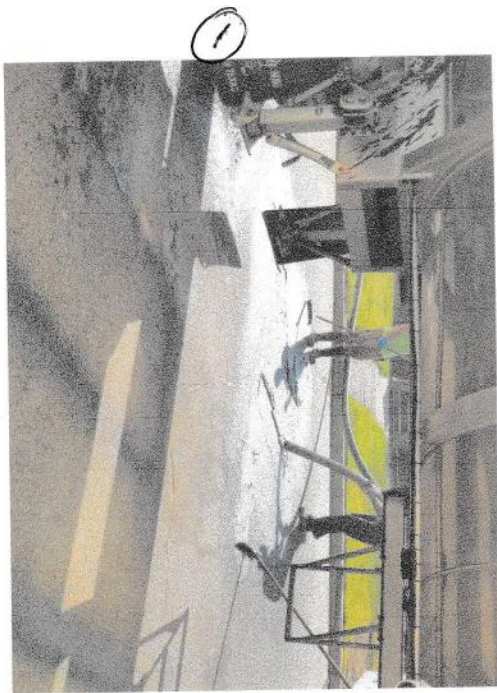
- picture 1 - area of sludge on Bay side of truck - very localized
at truck.
- 2 - cleaning/vacuuming up of sludge
- 3 - washed down area (driveway)
- 4 - sludge truck tanker vent
- 5 - area clean-up - contained within sand bags,

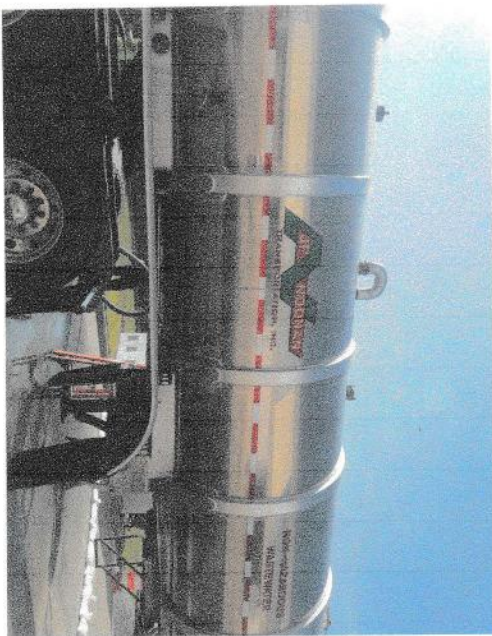
6. Cause of SSO Event: Other - Specify Below
Rain Event, PS Failure, Insufficient Capacity in System, Treatment Unit failure, Sewer System Blockage, Pipe Collapse, Root Intrusion, Grease Blockage, Other
Specify: Other: Operator error. Truck driver was monitoring filling of truck using the truck's sight glass, which did not indicate adequately how full the tanker truck was. The notification to shut off feed pump was made a little too late, causing slight overfill.

Review truck filling SOP with staff and trucking company. Truck driver should be inspecting the tank filling from the top
of the truck trailer.
